Derailment of Coal Train EG37

Connors Range

1 July 2001

October 2001

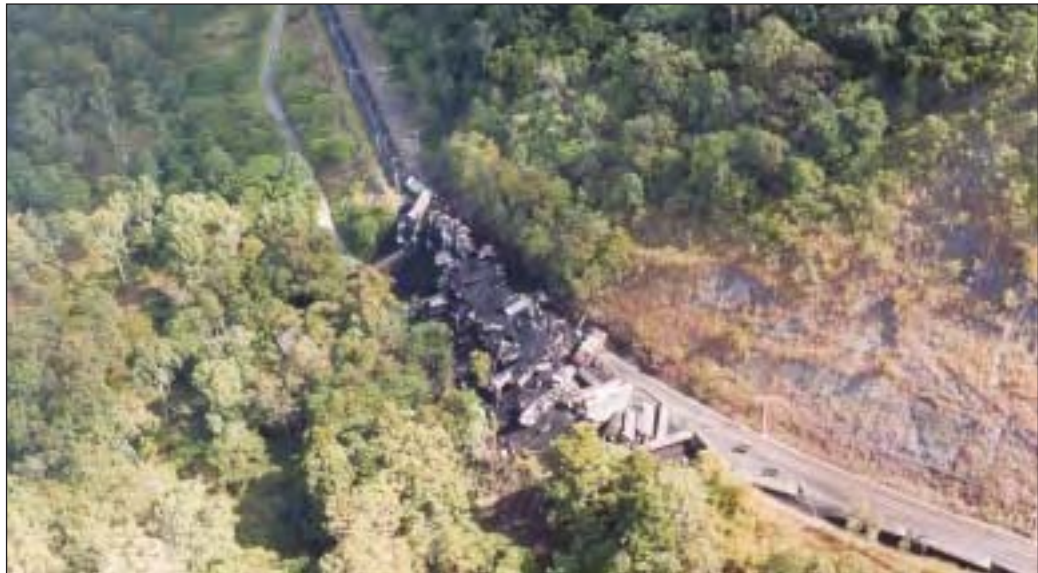
Figure 3:
General view of accident site

Within seconds of separating from the rest of the train, the front portion of the EG37 commenced to rapidly decelerate. It stopped some 123 seconds later and approximately two kilometres beyond the point of separation.

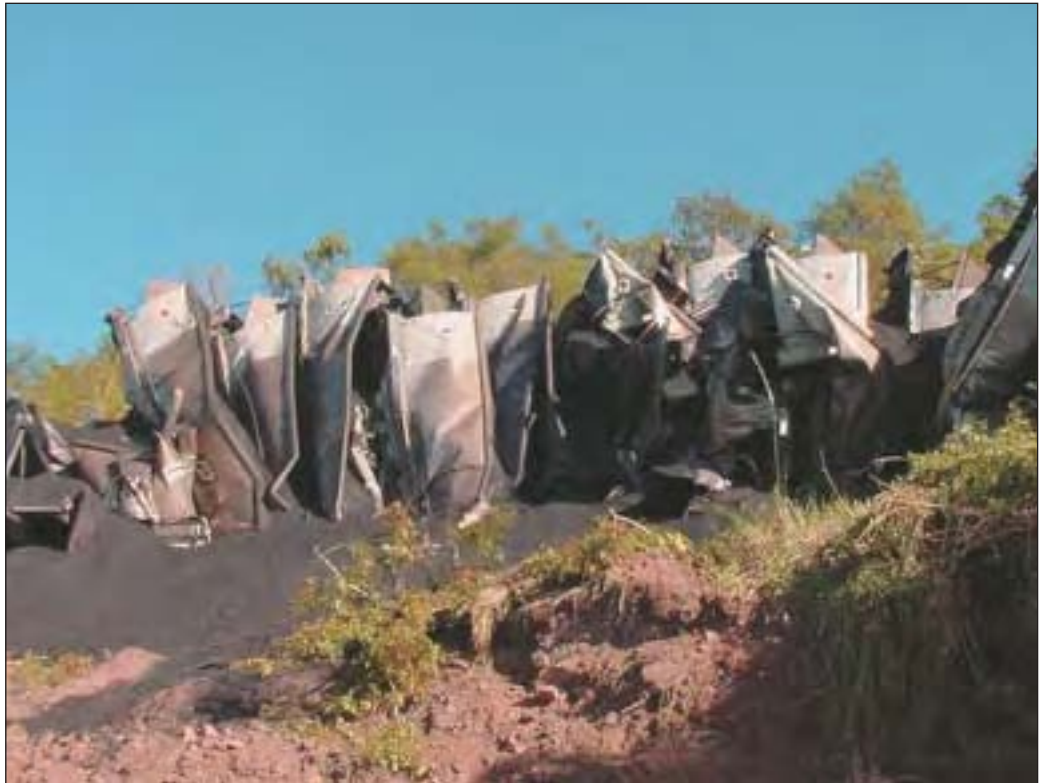
Figure 6:
View of derailment site showing several wagons 'stacked' vertically

The main wreckage, including 73 wagons, the two remote locomotives and the ELRC, was confined within a distance of 276 m (The normal operating length of that part of the train prior to the accident was 1,211.7 m). Several wagons were 'stacked' vertically (see fig. 6) and many others were 'buried' under other wagons and coal (see fig. 7). They had all experienced significant impact forces during the accident sequence and were substantially damaged. However, the main portion of the ELRC was relatively undamaged and was located on top of several wagons (see fig. 8).

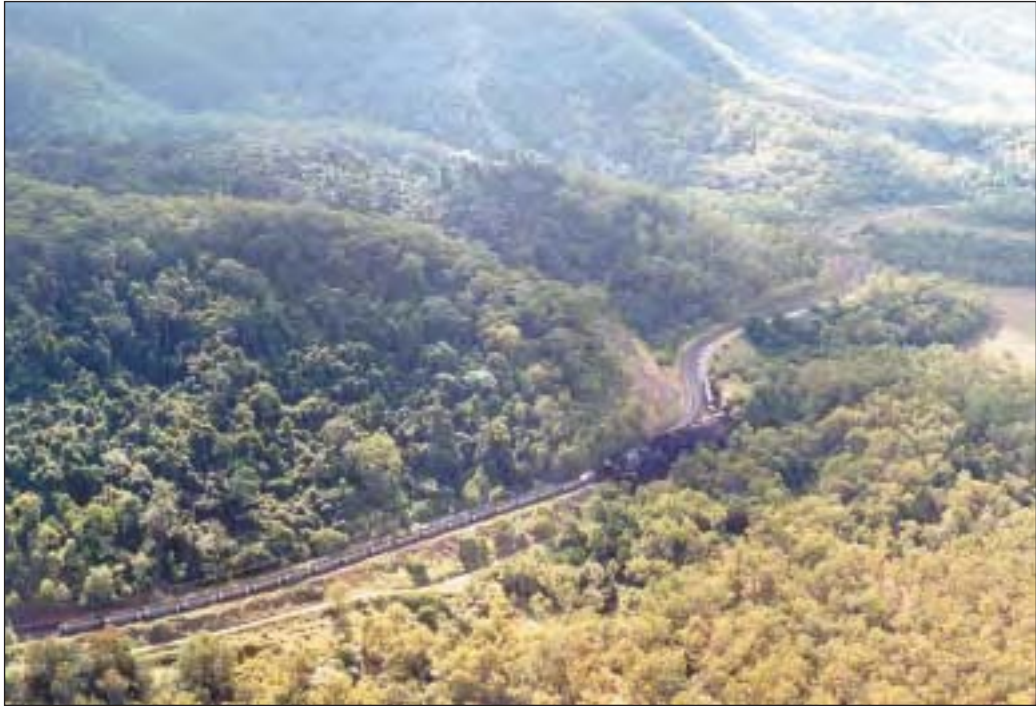
Figure 9:
View of derailment site showing trailing 18 wagons, which remained on the track

The trailing 18 wagons of EG37 remained on the track after the derailment. Those wagons were later attached to a diesel locomotive and taken back up the Connors Range where they were stowed at Hatfield (see fig. 9).

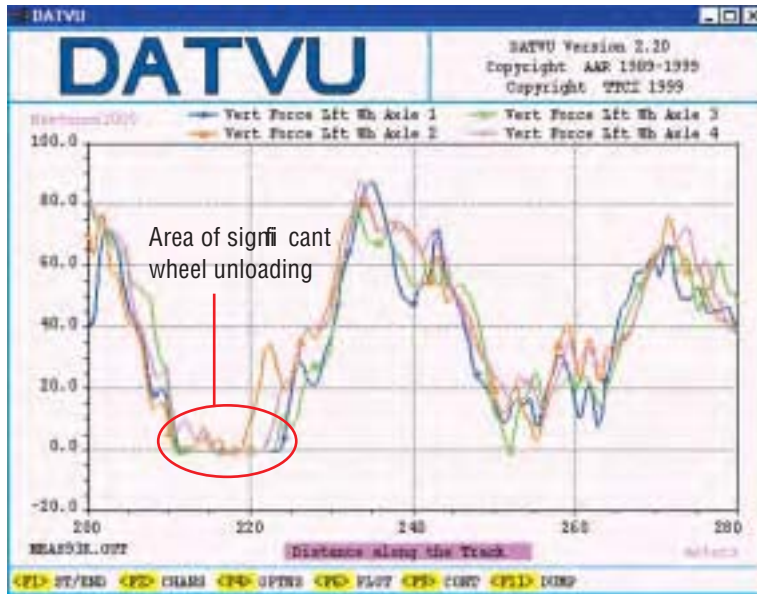
Figure 14:
NUCARS simulation showing total unloading of wheels on the low rail for approximately 10 m in area of derailment

It was concluded from the simulations that the cause of derailment was dynamic overturning of one or more wagons at a speed of 93 km/h. That dynamic overturning occurred about the high rail at the end of the entrance transition of the curve approximately 37.59 km from Hay Point. The resultant forces were affected in part, by minor variations to the correct cant and curvature of the track at that location.

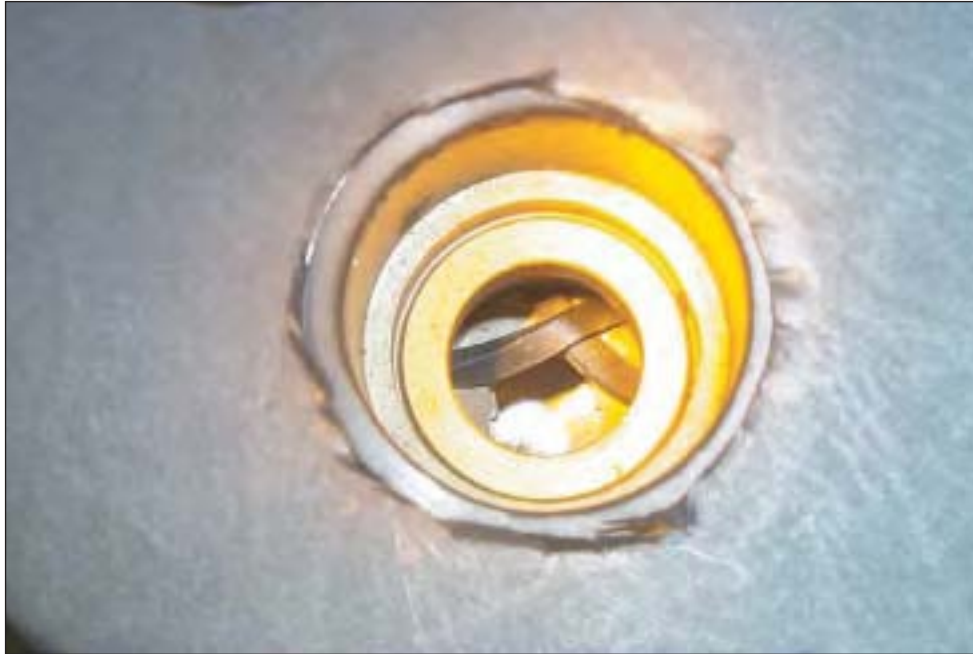
Figure 16:
Errant O-ring found lodged in seat of cut off portion of the Brake Pipe Control Valve on ELRC119

Upon disassembly of the Brake Pipe Control Valve, an errant square-section O-ring was observed to be lodged in a figure-8 shape across the seat of the Brake Pipe cut off portion of the valve and was holding the Brake Pipe Cut-Off Valve open (see fig. 16). This would have been the case even if the Main Reservoir air through '53A' were trying to close the valve (see fig. 17).

In normal train operations, recharging the Brake Pipe via that valve causes a large volume of air to pass through that port. It was considered that this would be sufficient to cause the O-ring to pass into the seat area of the cut off portion of the valve.

In a test of Brake Pipe recharges, an O-ring lodged under the valve seat and formed a figure 8, consistent with what was observed in the Brake Pipe Control Valve found in EG37.

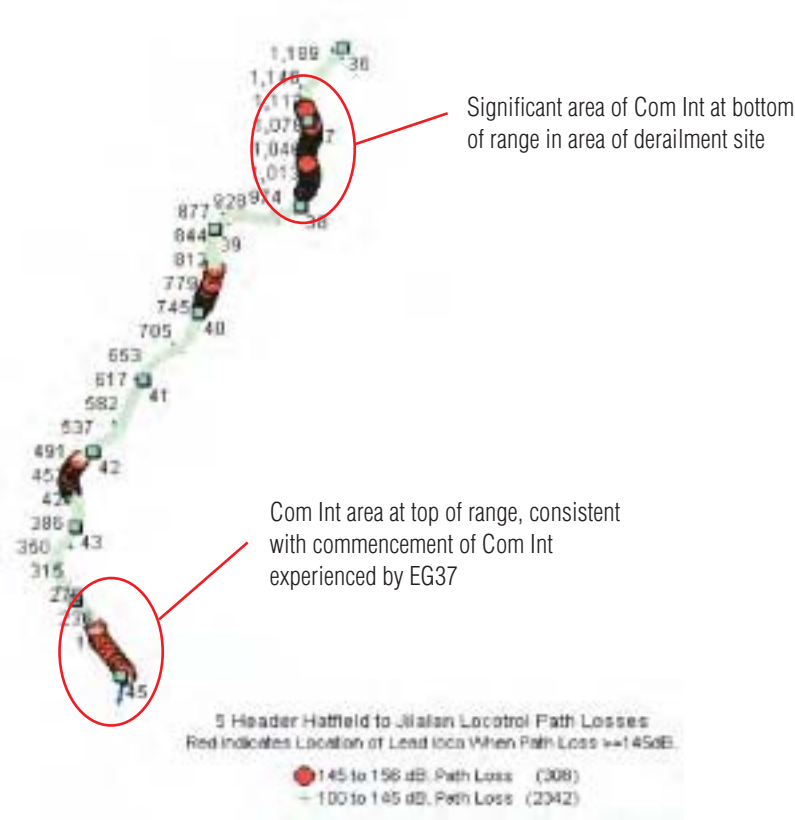
Figure 19:
Locotrol 'Path Loss' Black Mountain 45 to 36 Km. 5-Header train travelling down the range

The results of those tests indicated that there were two significant areas of communications interruptions of varying duration and some other smaller areas (see fig. 19). The reason for the loss of radio signal was considered to be terrain shielding. Note that the tests were completed following the accident on trains travelling at modified speeds (maximum 35 km/h). It was therefore considered more likely that longer and more frequent communication interruptions would be evident during those tests.

One of the significant communications interruption areas identified during the tests was consistent with the area reported by the Driver of EG37 as being the location where the Com Int commenced. That location was also consistent with reports from other Drivers.

The tests also revealed that 5-header trains were more likely to experience longer Com Ints than 4-header trains, simply due to the greater distance between the aerial on the lead locomotive and that on the ELRC of 5-header trains.

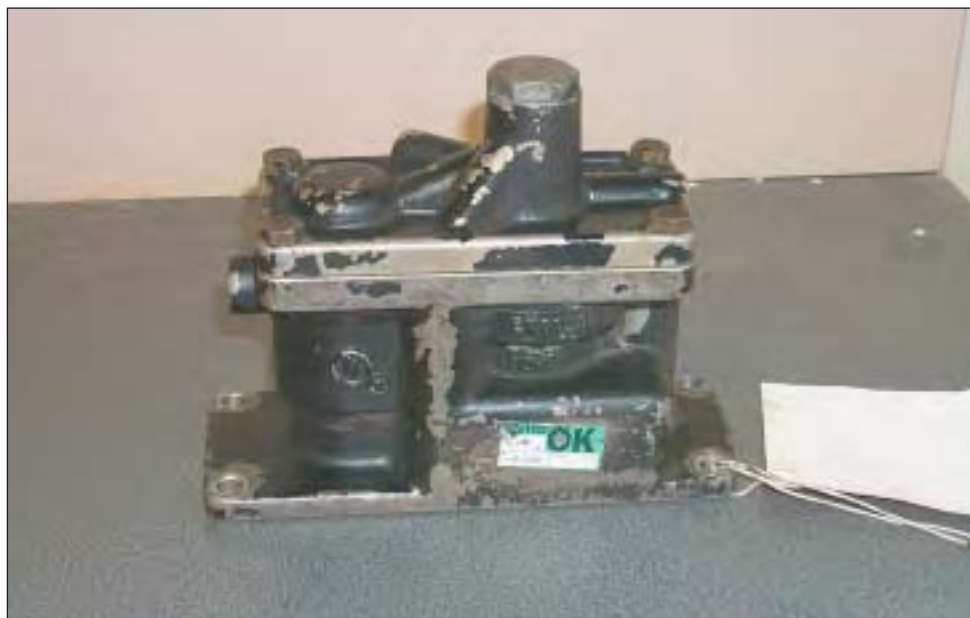
Figure 20:
Brake Pipe Control Valve from ELRC119

As previously stated, Brake Pipe Control Valves undergo a 144-week cycle of overhaul and inspection including the replacement of certain items such as all O-rings. A sticker on the outside of the Brake Pipe Control Valve from ELRC119, indicated that the unit had been overhauled and ‘Tested OK’ on 19 January 2000 (see fig. 20).

A Brake Pipe Control Valve with an obstruction to simulate the inoperative valve on ELRC119, was subjected to a bench test to determine if the fault should have been identified at the time of the bench test on 19 January 2000. That test was based on the assumption that the O-ring was already jammed in the seat of the valve at the time of the bench test. The Brake Pipe Control Valve failed the bench test in four separate areas of the test.
